MINISTRY OF TRANSPORT

RAILWAY ACCIDENTS

Second interim report on the
Accidents and Failures
which occurred in
Multiple Unit Electric Trains in the
Scottish Region and Eastern Region
British Railways

30th May, 1961.

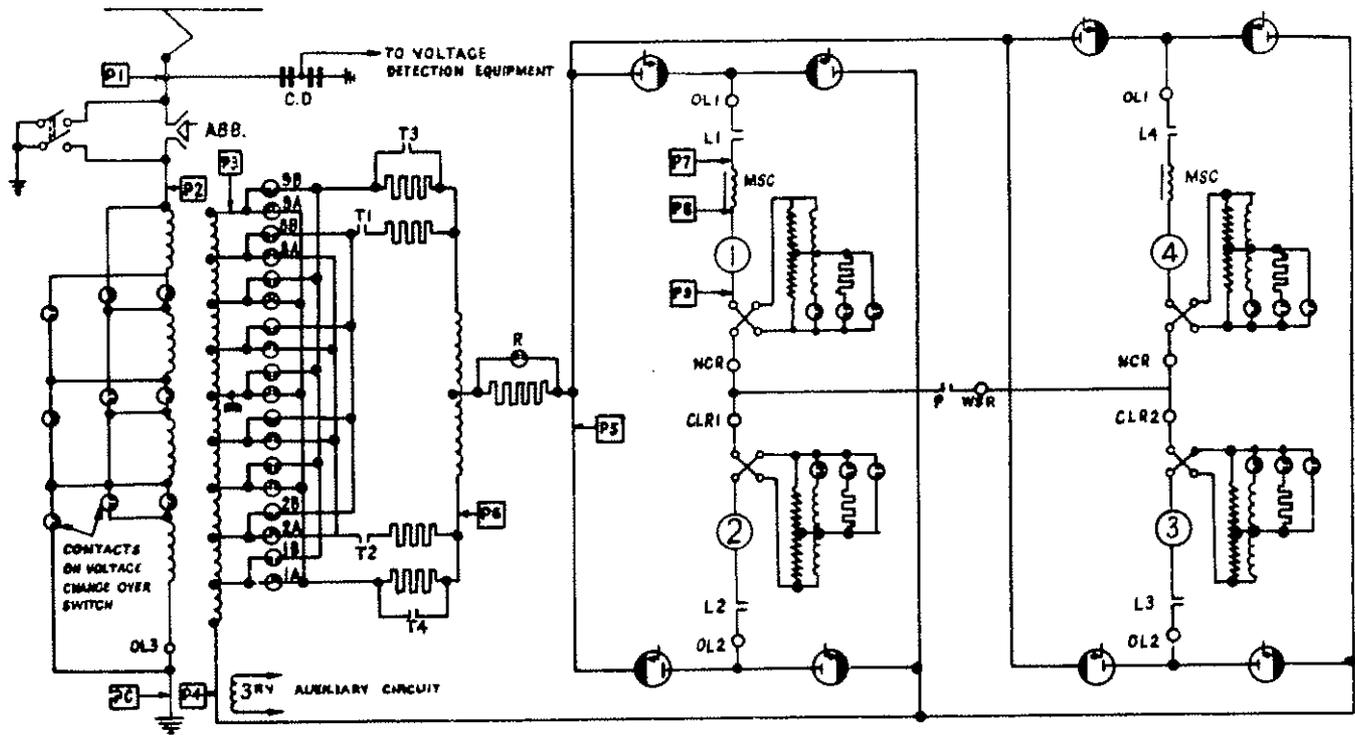
G.E.C. UNIT. SCHEMATIC DIAGRAM OF MAIN POWER CIRCUITS

23. The schematic diagram on page 8 shows the main power circuits. The current from the overhead conductor is collected by the pantograph and after passing through an air-blast circuit-breaker (A.B.B.) on the roof, it is carried through a heavily insulated cable to a voltage changeover switch which connects the four sections of the transformer primary winding in series for 25 kV operation or in parallel for 6.25 kV operation. The return current from the transformer is fed to the wheels through brushes on each axle of the motor coach.

The transformer secondary winding supplies current to two circuits, each feeding two traction motors in series through a group of four single anode mercury arc rectifiers.
